Montana Department of Transportation  
Research Program  
Helena, Montana

May 2002 Annual Report  
(Informal evaluation)

Fairfield North & South, STPP 3-1(15)18  
Highway 89 (P-3), MP 18-28 (approximate)

Project Description: 60 mm Cold In-place Recycle, CMS-2 – 60 mm Plant Mix  
Bituminous Surface

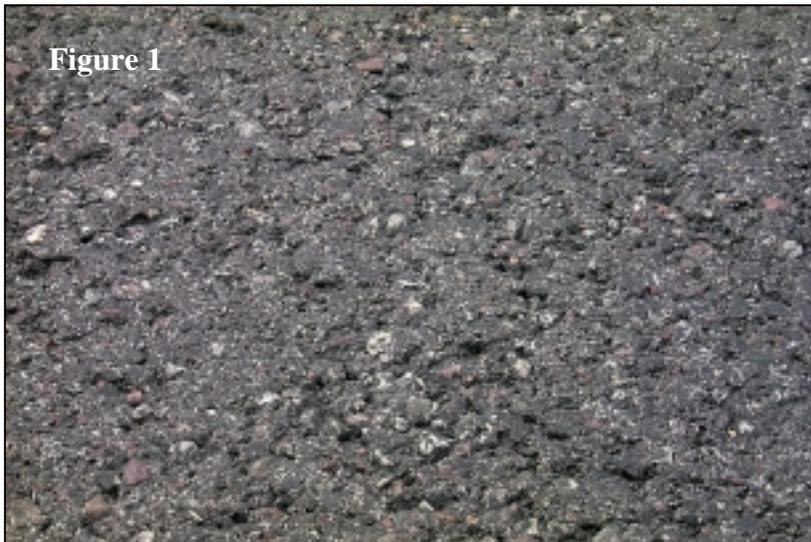
milepost 26, a low severity longitudinal cracking was observed in the southbound outer wheel path for a length of approximately fifty feet (15 meters). One small pop-out was seen, most likely caused from winter plowing. Figure 1 represents the surface texture throughout the project. The appearance was coarse with color of the aggregate

showing through the emulsion. This was much more apparent in the wheelpaths and can be attributed to wearing from traffic. A seal and cover will benefit the surface protection of the pavement type. Figure 2 shows an example of a low-severity transverse

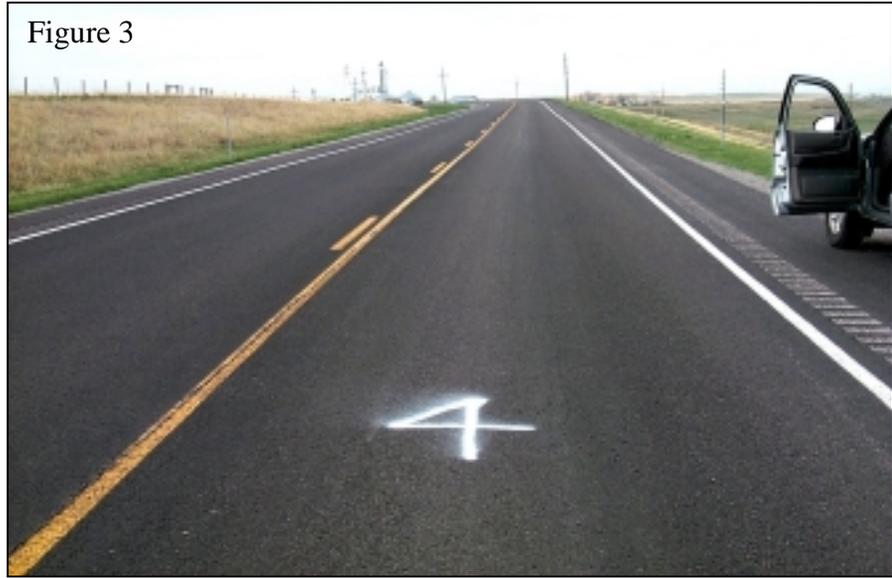
cracking at milepost 28. Shoulder cracking was observed at most of the data sites, although slight in severity it will be monitored closely for reflective cracking in future evaluations. Figure 3 is a sample representation of the pavement for the entire project. Based on initial evaluation data this project has been rated as performing well. Additional information on this project is available at the MDT Research website. The next schedule inspection will be summer of 2003.
